# Finding Success with T&S:

## Water audits

### T&S water audits are a comprehensive evaluation of water use within a facility.

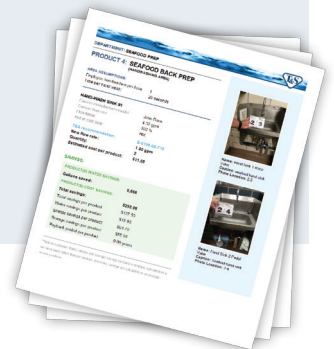
- Measure faucet and spray valve flow rates
- Identify any drips or leaks
- Measure water loss from drips or leaks
- Inspect fixtures for appropriate use and adequate function
- Calculate potential savings with repairs and updates

A few faucet bodies were replaced as needed, but most of the existing T&S faucets, some of which had been in use for 40 years, were retrofitted with Cerama cartridges and low-flow aerators to resolve leaks and reduce water usage. These included fixtures used in hand sinks and prep sinks.

For example, two of the kitchen's prep sinks, which previously were measured at flow rates of 13.3 gpm and 16.3 gpm, saw a dramatic reduction when fitted with 2.2 gpm aerators. Likewise, a hand sink was fitted with a 1.0 gpm aerator after the water audit measured it at 1.68 gpm water flow.
